1350 Ala Moana Pipe Replacement Project

Owners Forum Meeting 1350 Ala Moana January 17, 2013

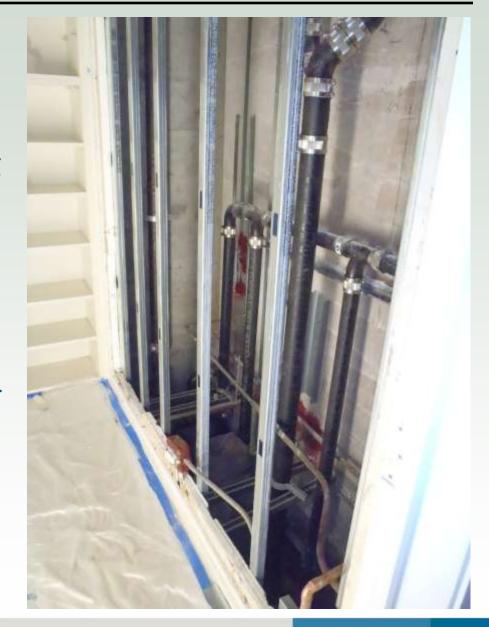
Description of Existing Plumbing Systems:

- Drain / Waste / Vent (DWV)
- Domestic Water Supply
- Rain Leaders

All located within firerated plumbing shafts that extend vertically through each apartment unit in entire building

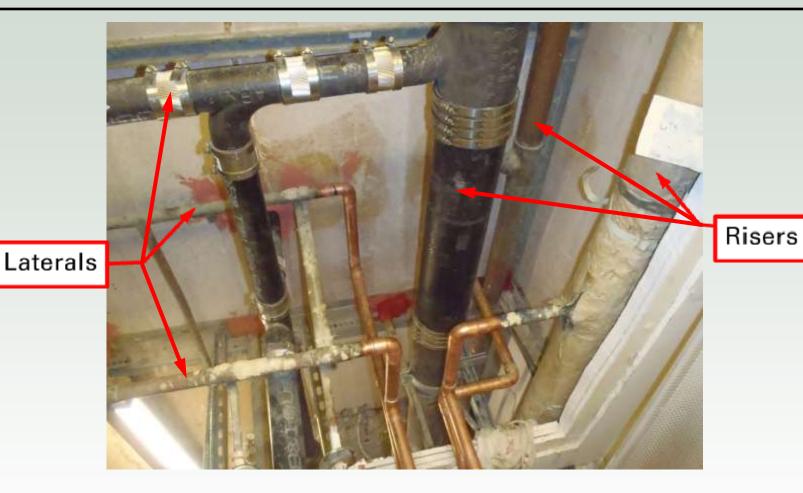
Basic Overview of Plumbing System

Risers run vertically through building, serving multiple apartment units in a stack; laterals run horizontally serving one apartment unit only

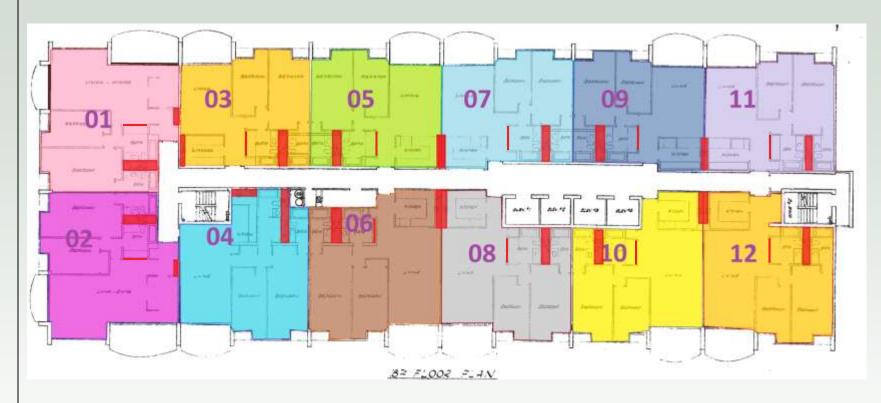
Typical Floor Plan & Chases

- Thirty-one plumbing shafts throughout the building, extending from 3rd floor through roof
- Typically 2 3 per apartment unit, including 1 shared between adjacent kitchens

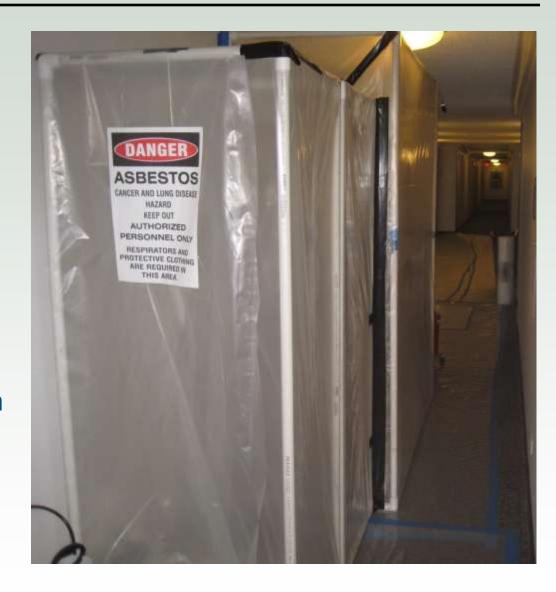
- Asbestos abatement work
 - Must be performed by licensed environmental subcontractor
 - Isolate work
 areas to contain
 friable material
 - Removal of all ACM from unit prior to remaining work

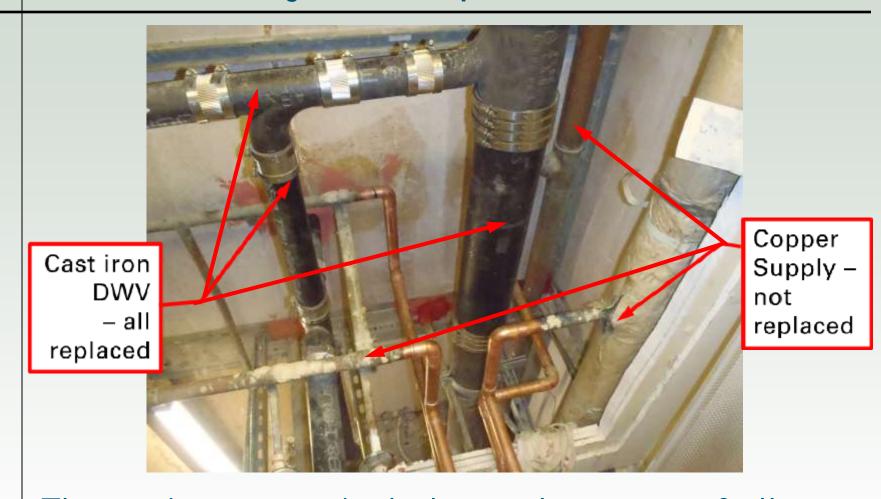
The project scope includes replacement of all cast iron DWV risers and laterals; only visibly defective copper supply lateral piping is replaced

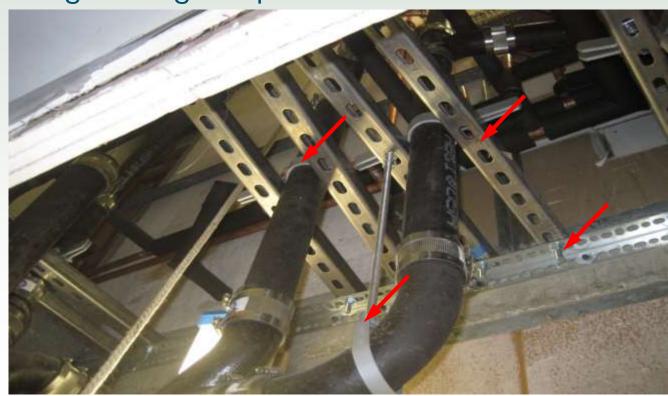
New pipe supports are being installed to meet revised seismic Code requirements, as well as to prevent pipe from falling down the chase and causing damage to persons or materials below

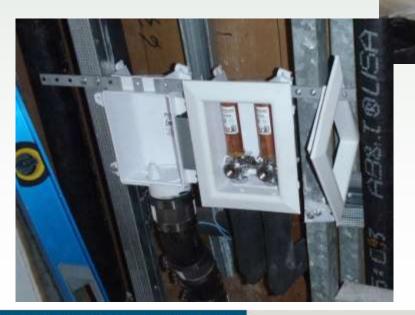
- Unit isolation ball valves to shut off service to each unit (in bathroom)
 - In case of leak , system can be isolated more quickly
 - Individual unit renovations can be made without affecting all the units in a stack

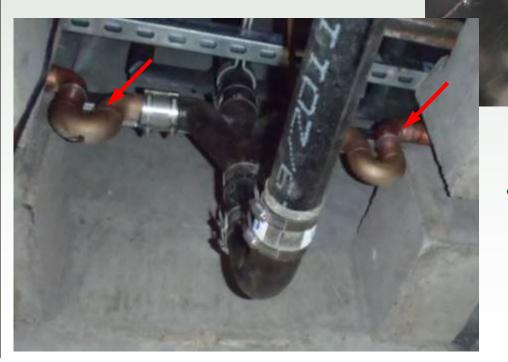
Installation of pipe insulation on hot water supply laterals (from riser connection to fixture connection)

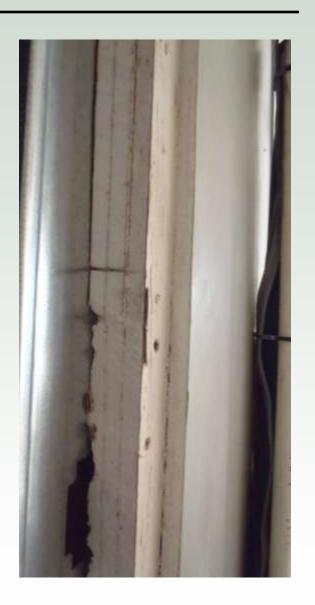
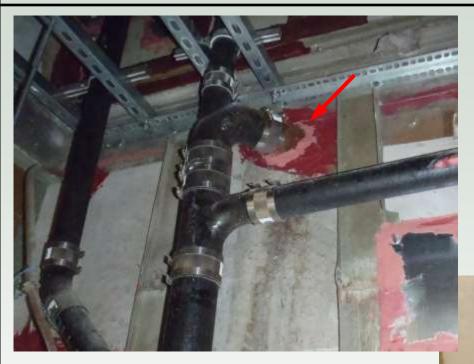
Fire rated drywall assembly

- Four layers of drywall must be repaired according to Code standards for fire-rated walls
- Edge must be staggered to prevent direct flame path through wall
 - Second cut required at perimeter of each opening = extra labor
- Patch must be properly supported with steel studs
 - No studs present in existing wall assembly, so new framing required throughout repaired walls
- Tape, mud, & paint finish to match surrounding wall

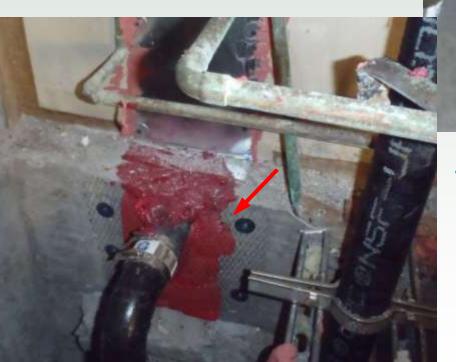
Various gaps existed in original construction that required fire protection

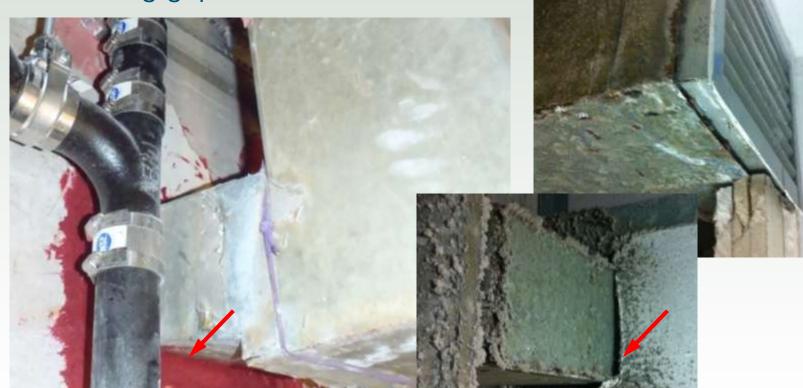
Exhaust vent sub-ducts required fire stopping at existing gaps

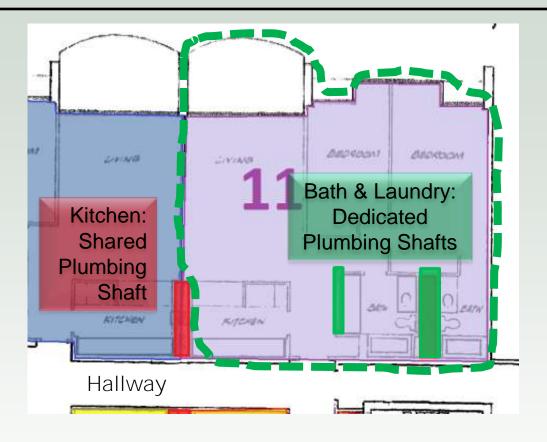
Building components that are within the apartment perimeter wall lines are owned by the unit owner; items outside the perimeter wall line of an apartment are common elements

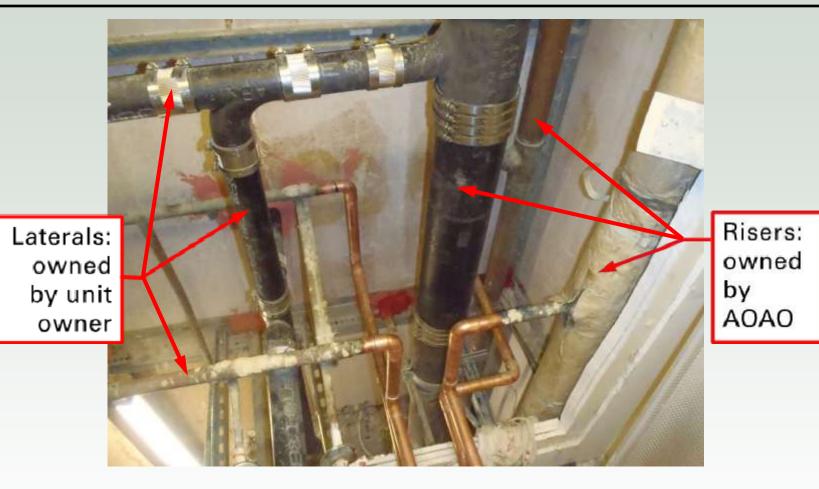
Risers serve multiple apartment units, and are owned by the AOAO; laterals serve one apartment unit only, and are owned by that unit owner

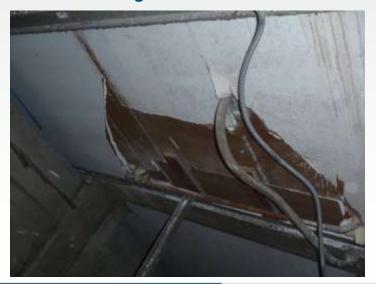
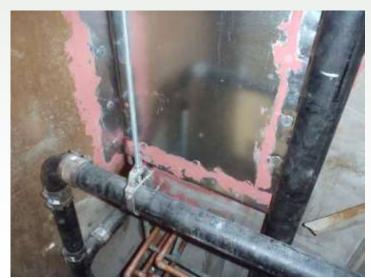
Unit Owners are also responsible for the costs of any additional work required in their units as a result of existing code deficiencies or hazards uncovered during the process of completing the project scope of work. These costs will be tracked per unit and charged back to the unit owners at the conclusion of work in each unit. Costs for such additional work so far range from \$80 - \$5,000 per unit, depending on the severity of the defects.
